# Fire Risk Assessment

BS 9792:2025 — House in Multiple Occupation —  
EXAMPLE REPORT

**27 Example Road, Southampton, SO99 9XX**

Document type: FIRE RISK ASSESSMENT — BS 9792:2025. Prepared by ClearFire Compliance.

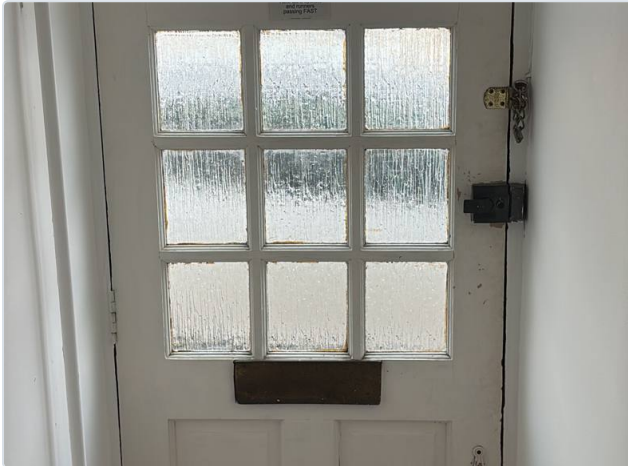
### P1 — Front final exit

Night latch with thumb-turn at mid-height; key-only mortice deadlock below, used at night. Action A1.

| # | Priority | Ref | Timeframe | Recommended action | Action by whom |
|---|---|---|---|---|---|
| A1 | URGENT | Protection 2 | Within 7 days | Make both final exits openable from inside without a key: fit a thumb-turn cylinder to the rear kitchen door's multipoint lock, and replace the front-door mortice deadlock with a thumb-turn type or remove it. See interim measure I1. | Managing Agent |

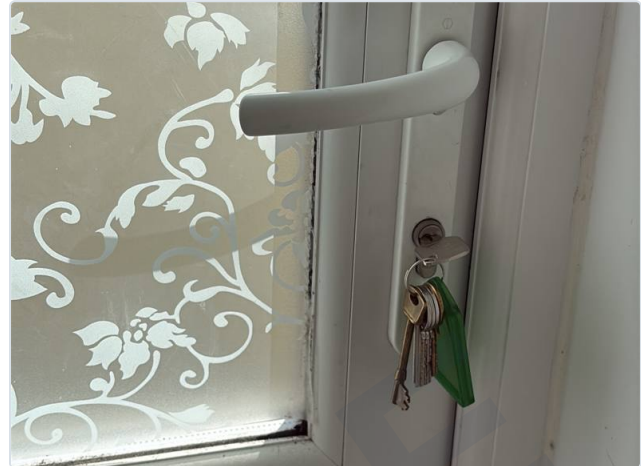
### P2 — Rear final exit — multipoint lock

Key-operated cylinder with the key left in it at the inspection; a removable key is not a reliable means of escape. Action A1.

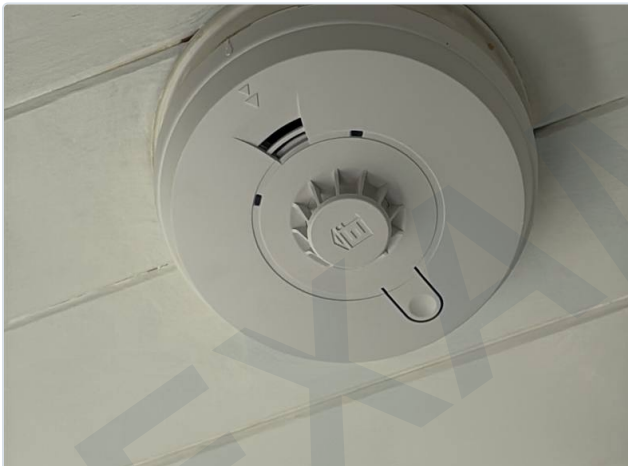
### P3 — Kitchen heat alarm

Manufacturer's label reads "Replace by Jul 2025"; the head is past its service life. Action A2.

| # | Priority | Ref | Timeframe | Recommended action | Action by whom |
|---|---|---|---|---|---|
| A2 | IMPORTANT | Protection 1 | Within 28 days | Replace all four alarm heads (hall, landing, living room and kitchen) with new interlinked mains-wired units with battery back-up of the same grade, and obtain the installer's certificate for the log book. | Managing Agent |

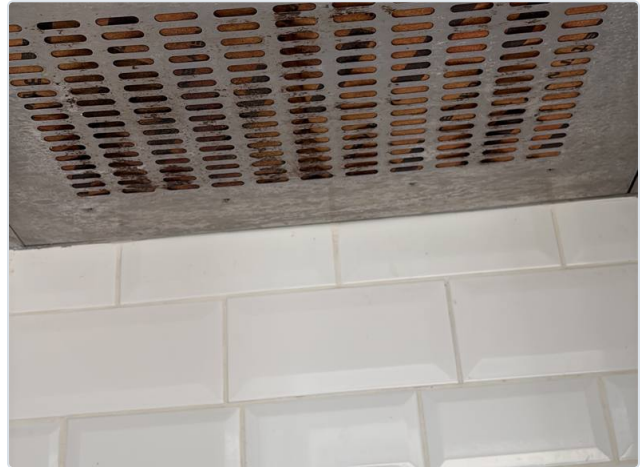
**P6 — Kitchen extractor hood**

Cooking takes place only in the shared ground-floor kitchen, which has an electric ceramic hob and oven; no cooking equipment was found in the bedrooms. The grease filter and underside of the extractor hood have a heavy build-up of grease, which is a ready fuel directly above the hob. The hood and filter should be degreased and a regular cleaning routine put in place. A heat alarm and a fire blanket are provided (see Protection 1 and 5). → **Action A4**

Heavy grease build-up on the filter and underside of the hood, directly above the hob. Action A4.

| # | Priority | Ref | Timeframe | Recommended action | Action by whom |
|---|---|---|---|---|---|
| A4 | IMPORTANT | Hazard 5 | Within 28 days | Degrease the kitchen extractor hood and its filter, and put a regular cleaning routine in place with the residents so grease does not build up again. | Tenants |

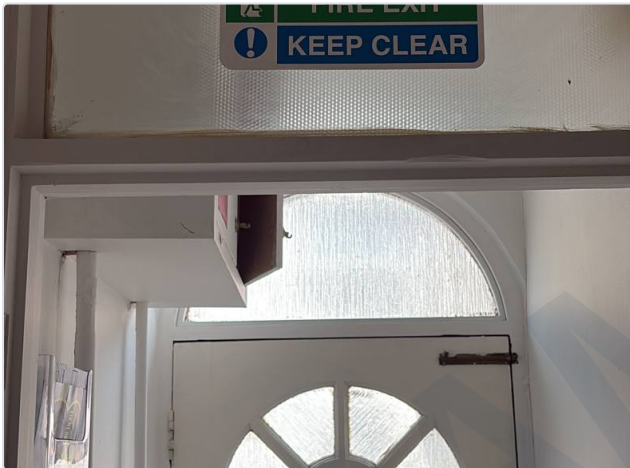
**P7 — Entrance hall to the front door**

The escape route discharging to the front door, with fire exit and keep-clear signage over the fanlight.

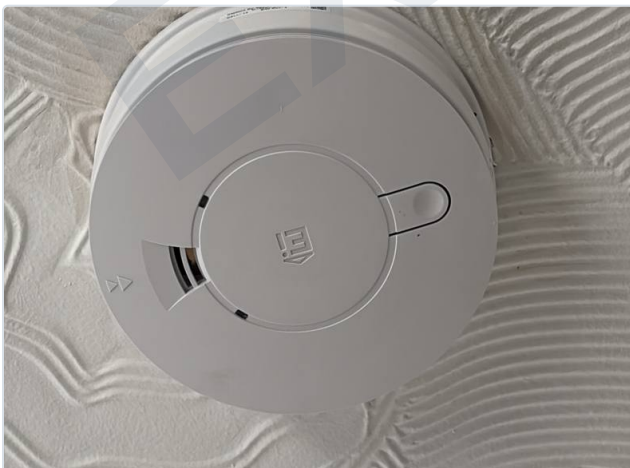
**P9 — First-floor landing smoke alarm**

A mains-wired, interlinked fire detection and alarm system with integral battery back-up is installed: smoke alarms in the hall and on the first-floor landing and in the living room, and a heat alarm in the kitchen. All alarms sounded together when tested. The coverage meets the Grade D, LD3 provision set out in LACORS Case study D4 for a two-storey shared house, BS 5839-6 and the Southampton City Council minimum. However, the heads are beyond their service life: the kitchen heat alarm carries a manufacturer's replace-by date of July 2025 and the label at the consumer unit records the circuit as installed in February 2014. Detectors are designed for a ten-year life, after which the sensor cannot be relied upon. All heads should be replaced with new interlinked units of the same grade. Routine testing and records are addressed under fire safety management. → **Action A2**

Mains-wired interlinked smoke alarm on the escape route; to be replaced with the other heads. Action A2.

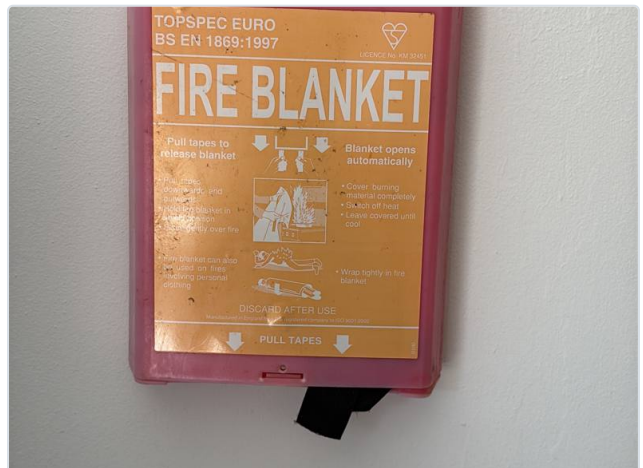
**P10 — Kitchen fire blanket**

A fire blanket is wall-mounted in the kitchen beside the cooker, with its pull tapes accessible, which meets the LACORS Case study D4 requirement. The provision is adequate as it stands. LACORS additionally recommends a simple multi-purpose extinguisher on each landing; providing one is a recommended betterment, not a shortfall. → **Action A8**

Wall-mounted beside the cooker with pull tapes accessible. Meets the LACORS D4 requirement.

| # | Priority | Ref | Timeframe | Recommended action | Action by whom |
|---|---|---|---|---|---|
| A8 | RECOMMENDED | Protection 5 | At next review | Recommended betterment: provide a simple multi-purpose extinguisher on the first-floor landing, as LACORS suggests, and add it to the annual maintenance and the routine checks. The existing provision is adequate without it. | Landlord/ Owner |

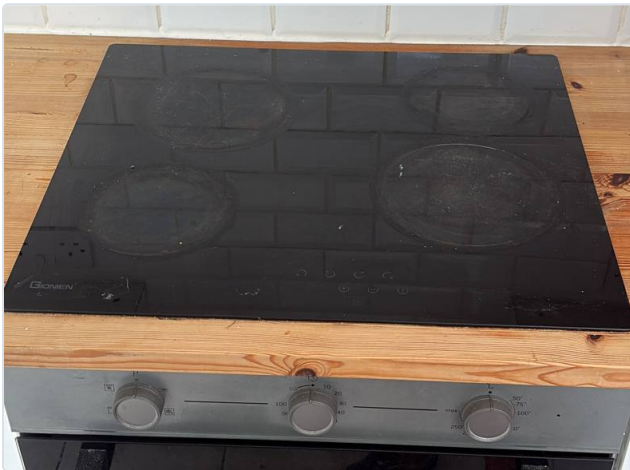
#### P11 — Kitchen cooker

Electric ceramic hob and oven; the only cooking facility in the house.

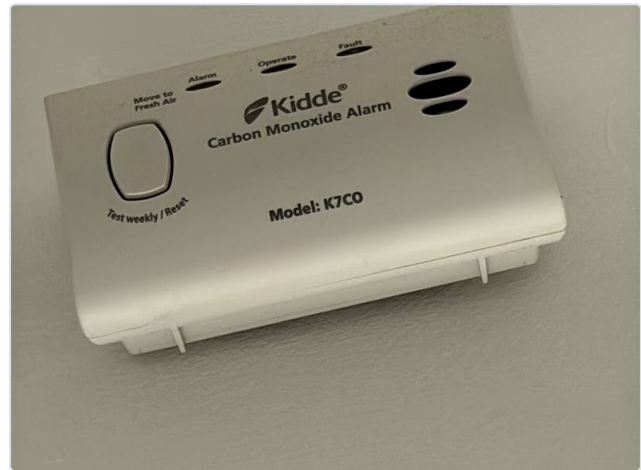
#### P12 — Carbon monoxide alarm

A wall-mounted gas combination boiler in the kitchen serves the central heating and hot water; it appeared in good order with no signs of scorching or leakage, and a carbon monoxide alarm is fitted in the kitchen. Confirmation of a current gas safety record is addressed under fire safety management.

Fitted in the kitchen serving the gas boiler; tested and sounding.

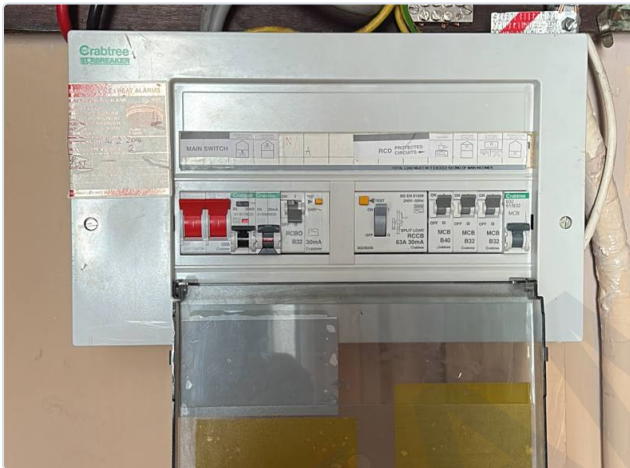
#### P13 — Consumer unit

The fixed electrical installation appeared in good order, with a split-load consumer unit providing RCD protection and no damaged accessories or overloaded sockets observed. A current Electrical Installation Condition Report was seen and is in date and satisfactory. Portable appliance testing of the landlord-supplied appliances is addressed under fire safety management.

Split-load consumer unit with RCD protection; EICR seen, in date and satisfactory.

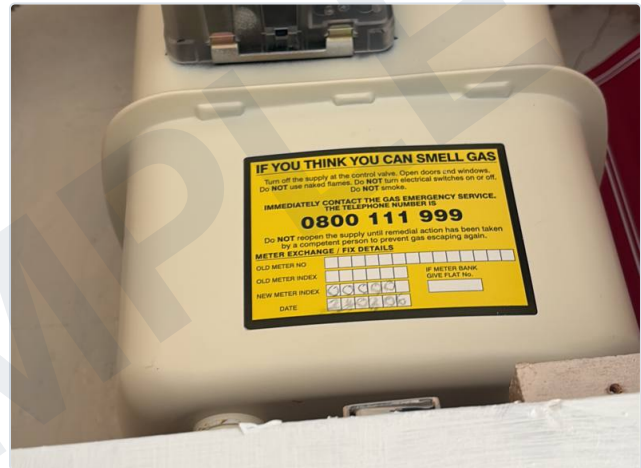
#### P14 — Gas meter

The Electrical Installation Condition Report was seen and is in date and satisfactory. The gas safety record for the boiler was not available on the day — the agent believes it is current and is to provide it. No portable appliance test records were available. The gas safety record should be provided, PAT records located or renewed, and both held with the log book together with the certificate for the replacement alarm heads (Action A2). → **Action A7**

Gas meter installation with emergency contact label; gas safety record to be provided. Action A7.

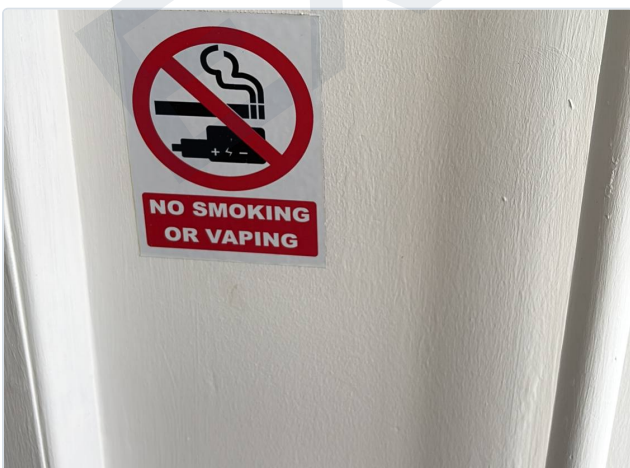
#### P15 — Hall signage

Fire exit and no-smoking signage in the hall; not required for this house type but present.

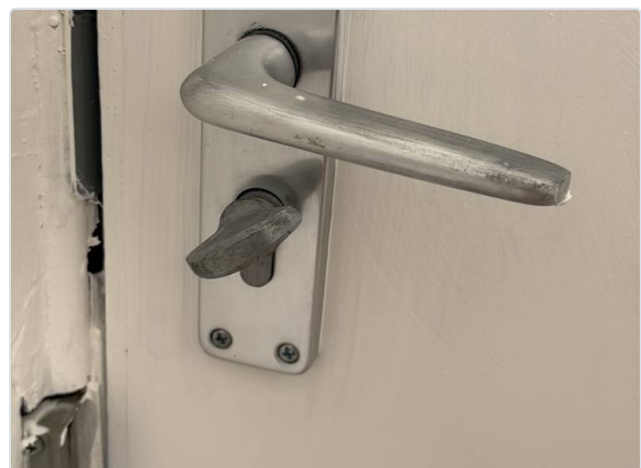
#### P16 — Bedroom door lock

Thumb-turn privacy lock; opens from inside without a key.

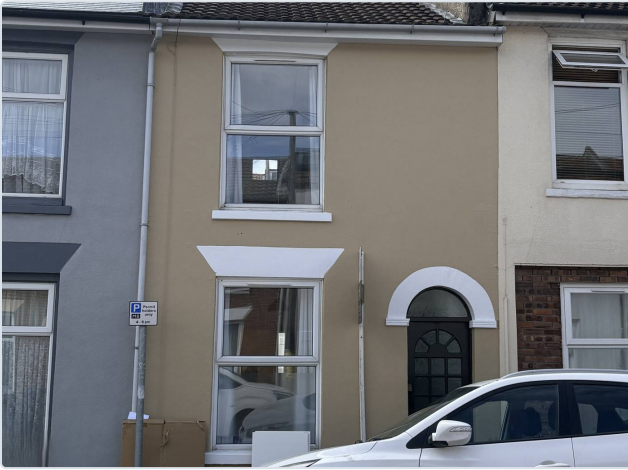
**P17 — Front elevation**

Two-storey mid-terrace house of solid masonry construction with a rendered front.

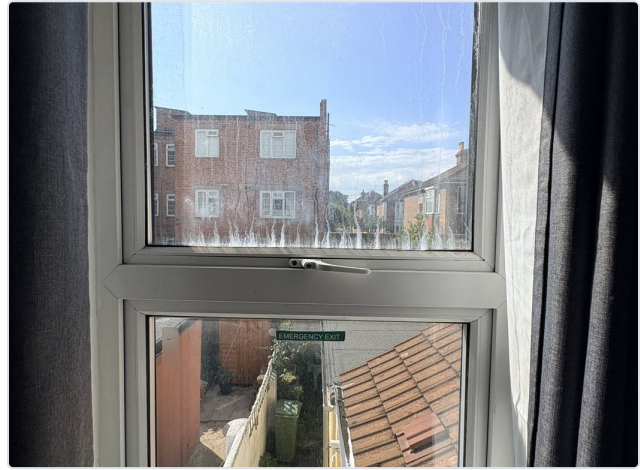
**P18 — First-floor rear window**

View to the rear yard and the gate to the rear lane, the discharge from the rear final exit.
