# Fire Risk Assessment

EXAMPLE REPORT — PAS 79-1:2020 holiday let

## Sandpiper Cottage, 14 Harbour Lane, Sandbourne, Dorset

Document type: FIRE RISK ASSESSMENT — PAS 79-1. Prepared by ClearFire Compliance.

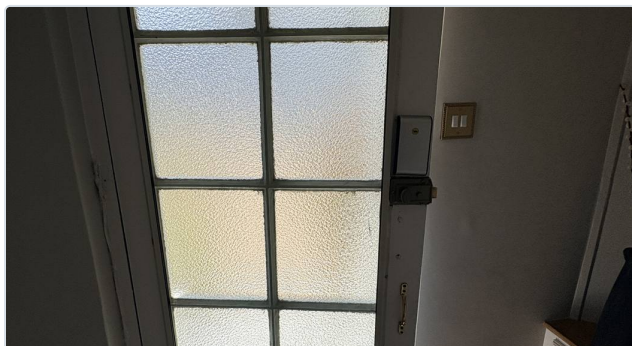
### P1 — 17 — Front door

Front door from the hall: nightlatch with internal thumb-turn — the primary final exit opens without a key.

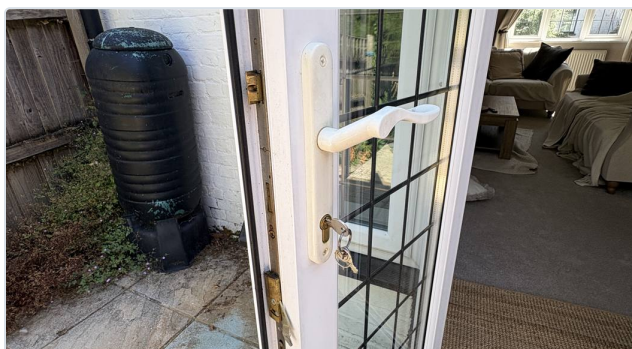
### P3 — A1 / 17.3d — French door, open

The same door from the patio: multipoint bolts and the key-operated cylinder to be changed for a thumb-turn.

| # | Priority | Ref | Timeframe | Recommended action |
|---|---|---|---|---|
| A1 | URGENT | 17.2f / 17.3d / 27.9 | Within 2 weeks | Replace the French-door euro cylinder with a thumb-turn cylinder so the lounge exit opens from inside without a key. Interim measure, from today: the key stays in the lock on the inside whenever the property is let, and the changeover check confirms it is there. |

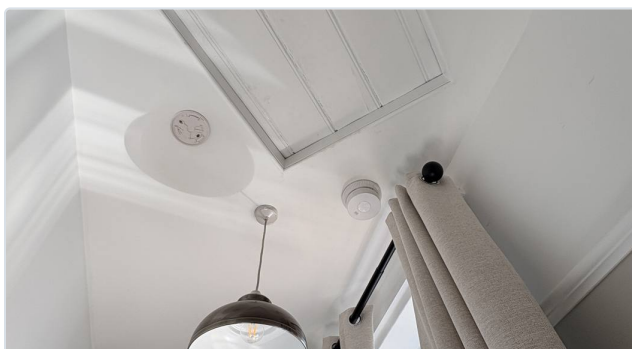
### P5 — 21.1 — Landing ceiling

Interlinked smoke alarm on the tower landing ceiling, at the head of the stair.

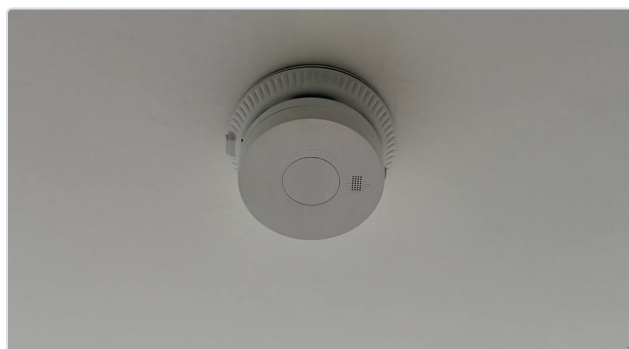
### P6 — 21.1 — Hall smoke alarm

Mains-powered interlinked smoke alarm at the foot of the stair; sounded with the landing and lounge alarms on test.

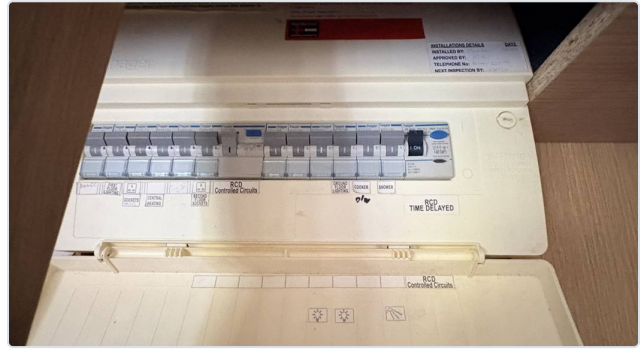
**P8 — A2 / 7.2a — Consumer unit**

The Electrical Installation Condition Report seen is dated June 2020 — more than five years old. The guidance expects inspection and testing at least every five years. Recorded as an overdue inspection, not as an observed installation defect. → **Action A2**

Modern RCD-protected consumer unit in the hall cupboard; the inspection report is overdue (June 2020).

| # | Priority | Ref | Timeframe | Recommended action |
|---|---|---|---|---|
| A2 | IMPORTANT | 7.2a | Within 1 month | Commission an Electrical Installation Condition Report by a competent registered electrician, remedy any C1 or C2 observations, and retain the report. Repeat at least every five years. |

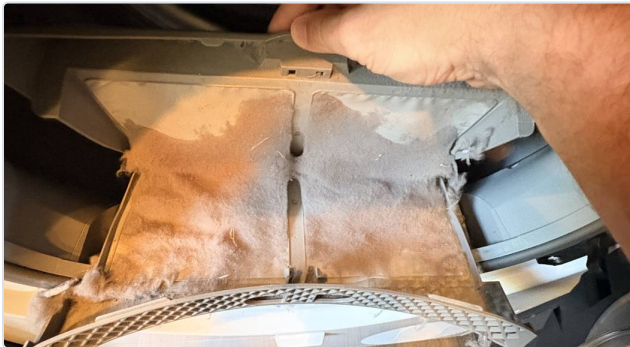
**P9 — A3 / 7.2b — Tumble dryer filter**

There is no statutory PAT requirement; the duty is to provide electrically safe equipment. The managing agent visually checks appliances, leads and plugs at each changeover. However, the tumble dryer's lint filter was found heavily blocked — a well-known cause of appliance fires — showing that the changeover check does not currently reach the dryer. The filter is to be cleared and its cleaning added to the changeover routine. → **Action A3**

Lint filter heavily blocked — the Important deficiency at Action A3; the changeover check does not currently reach the dryer.

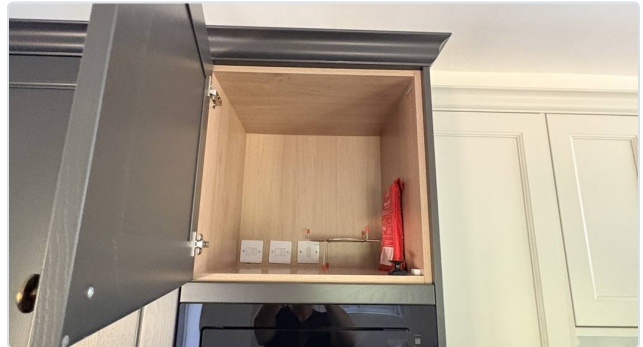
**P10 — A6 / 22.3 — Fire blanket**

The fire blanket is kept in the high cupboard above the built-in microwave and oven and is not visible to a guest who does not know it is there. It is accessible but would be more useful wall-mounted in view, and away from the appliance stack. Recommended betterment. → **Action A6**

Fire blanket in the high cupboard above the oven and microwave — to be wall-mounted in view.

| # | Priority | Ref | Timeframe | Recommended action |
|---|---|---|---|---|
| A6 | RECOMMENDED | 22.3 | At next opportunity | Wall-mount the fire blanket in the kitchen in plain view, away from the hob and the oven stack, so a guest can find it without being told where it is. |

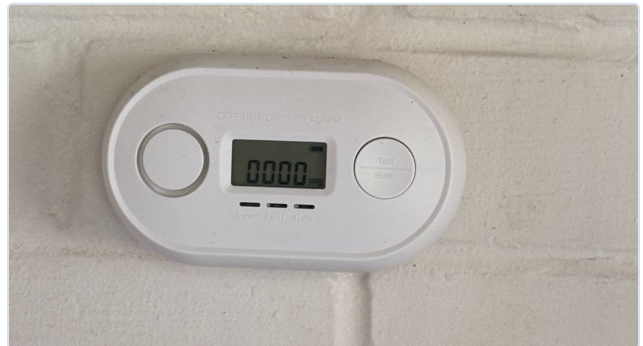
**P12 — 10.2 — CO alarm**

Carbon monoxide alarm on the boiler-house wall, reading zero; tested at changeover.

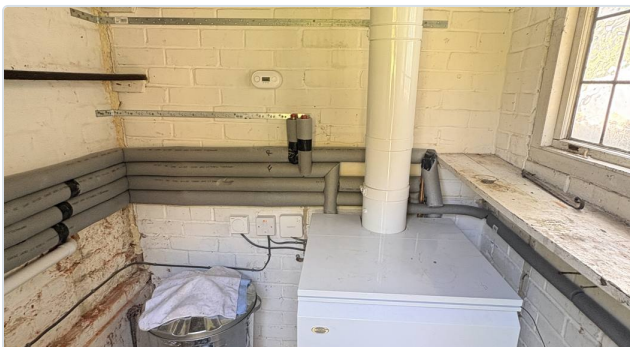
**P13 — 10.2 — Boiler house**

Oil-fired boiler in the detached boiler house; annual service record dated April 2026 seen (OFTEC-registered engineer). A carbon monoxide alarm is fitted on the boiler-house wall and tested at changeover. The boiler house is brick with a concrete floor, holds no combustible storage, and is not accessible to guests. Adequate.

Oil-fired boiler in the detached boiler house: masonry walls, concrete floor, no combustible storage, no guest access.

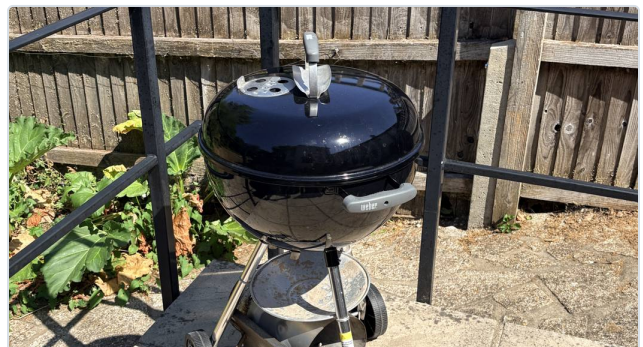
**P14 — 16.1 — Barbecue**

The oil installation is the principal additional feature and is controlled as described at 10.2 and 15.1. A charcoal barbecue and a fire pit are provided for garden use; the welcome folder asks guests to use them on the paved patio away from the fence and to leave ash to cool in the barbecue overnight. No other significant hazards.

Charcoal barbecue on the paved patio, clear of the fence — guest use governed by the welcome folder.
